# PCBs in Lighting Fixtures in Schools

Updated February 5, 2013

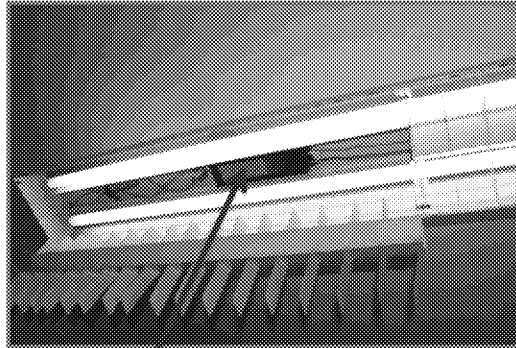
PCB-containing Ballast

This is what you might normally see when looking up at a light. Unfortunately, this PCB containing ballast had evidence of leaking but the light was still working.

Determined that widespread leaking PCB-containing lighting ballasts were contributing to elevated air levels

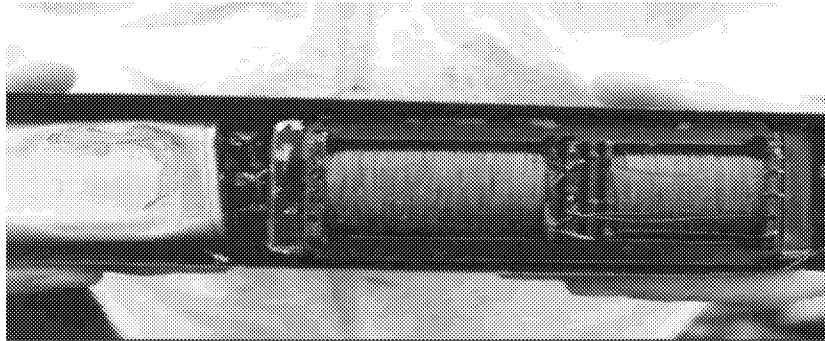
Thermal cut off switches were common place in mid-80s but EPA found thermal cut off switches in some ballasts that were manufactured in the early 70's. These ballasts appeared to have less leaking since they did not get as hot. Unfortunately, if they are leaking and get how, they shut down but after cool down reset and continue to work while leaking.

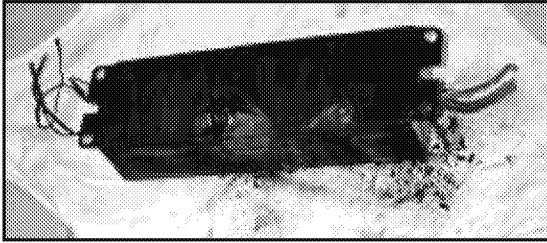
This ballast sparked a fire at a southern California school in 1999

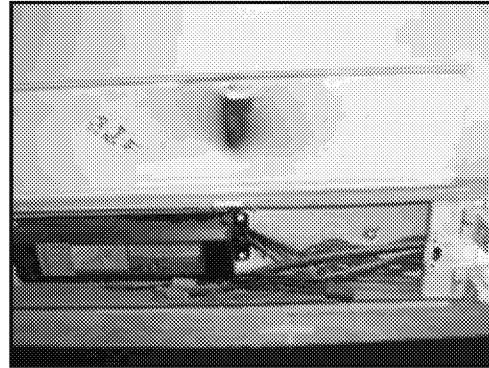
An old ballast that burst unexpectedly

During our inspections we found similar types of ballast failures.

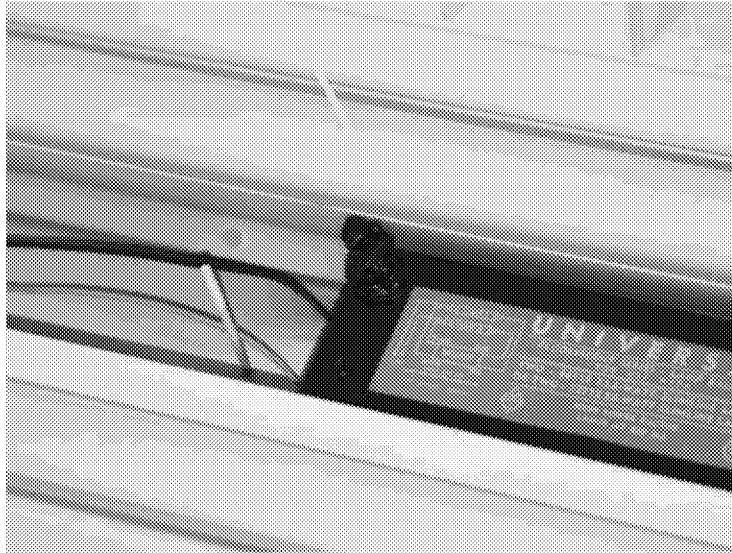
## Material Leaking From Corner of Ballast

Depending on the manufacturer, the age of the ballast, and whether the ballast is thermally protected, leaks can be noted in several areas. We have found that Universal ballasts are likely to leak from the corner.

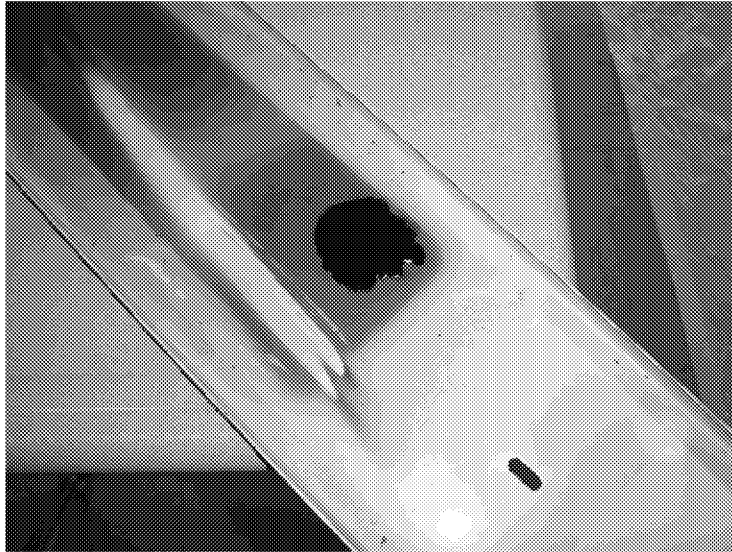
## Leaked Potting Material

Sometimes it leaks as a liquid – especially with very hot ballasts

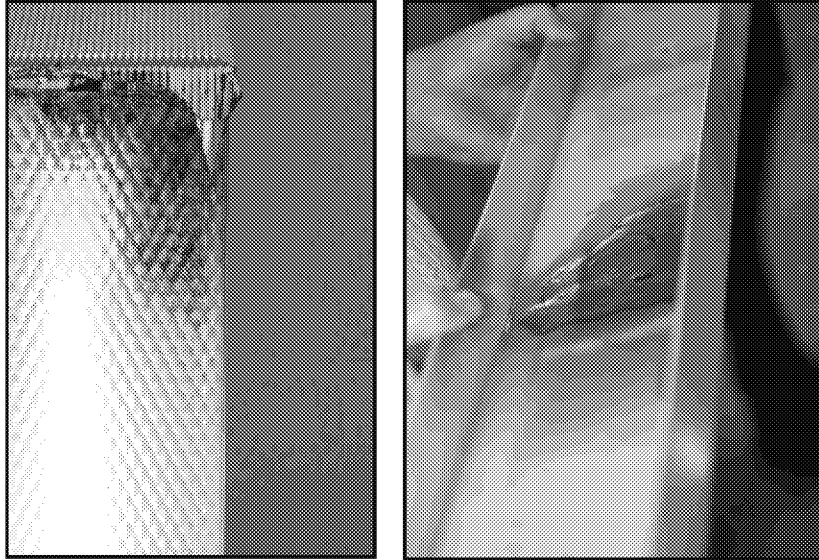
## Oily Stains

If you notice, the person holding the tray is not using any personal protective equipment and should have been wearing gloves

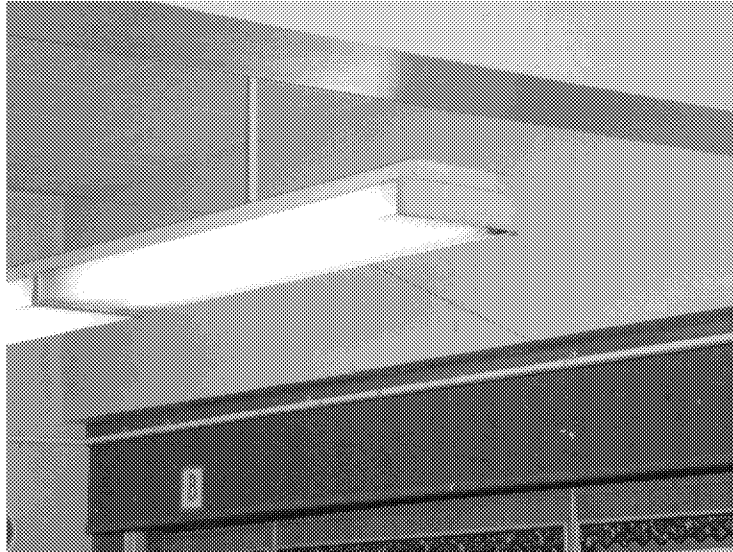
## **“Wrap Around” Type Fixture**

Sometimes the leaked material can travel into the adjoining fixture.

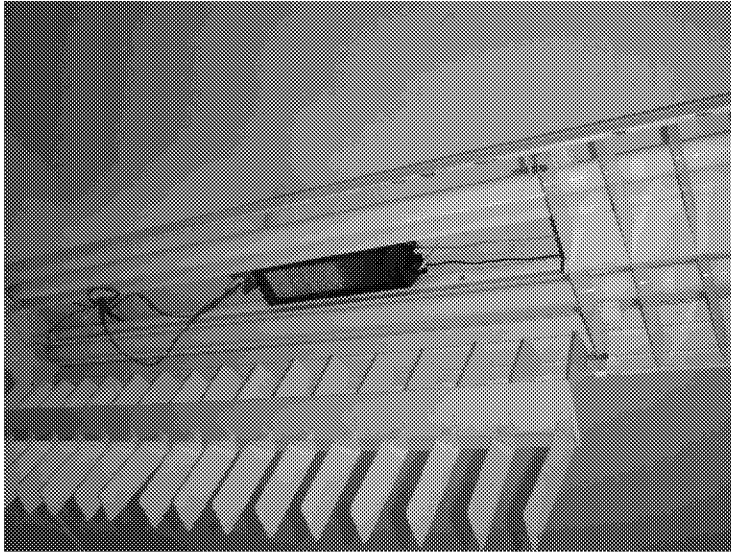
## "Egg Crate" Type Fixture

With the "egg crate" type fixtures, it is often difficult to see leaked material without opening the fixture.

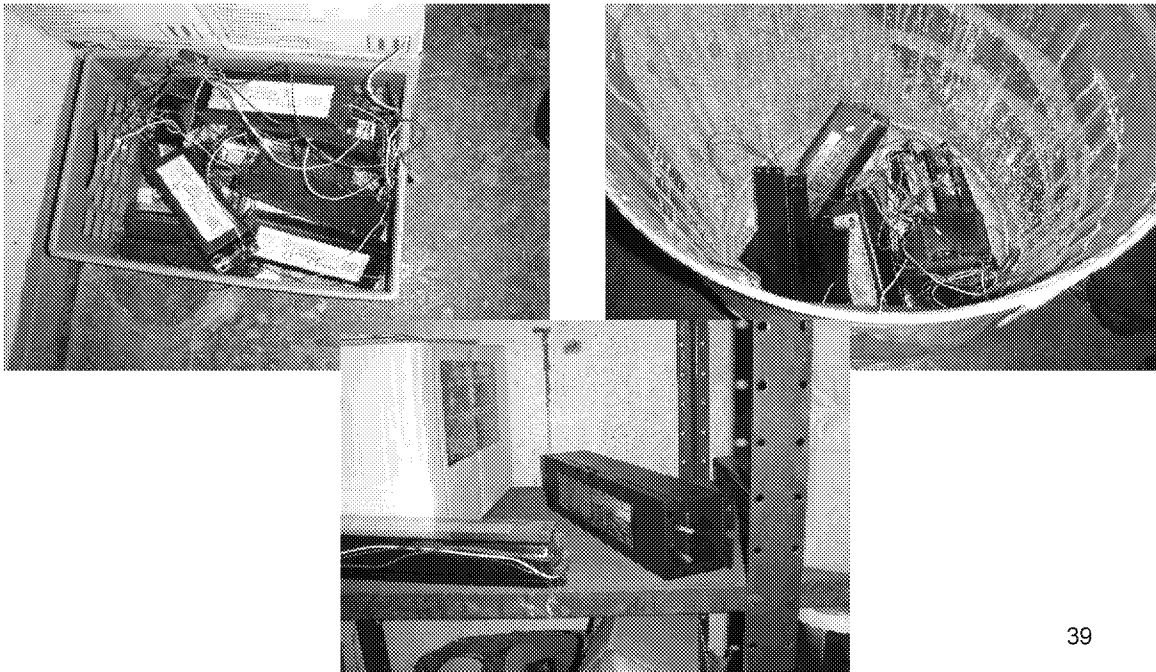
## Improper Storage of Old Ballasts

Sometimes they are stored in milk crates trash cans or just left on a table for anyone contact. Note the new ballast sitting next to the old one that leaked

Any leaking ballast has to be treated as a TSCA waste and needs to be handled and stored properly.

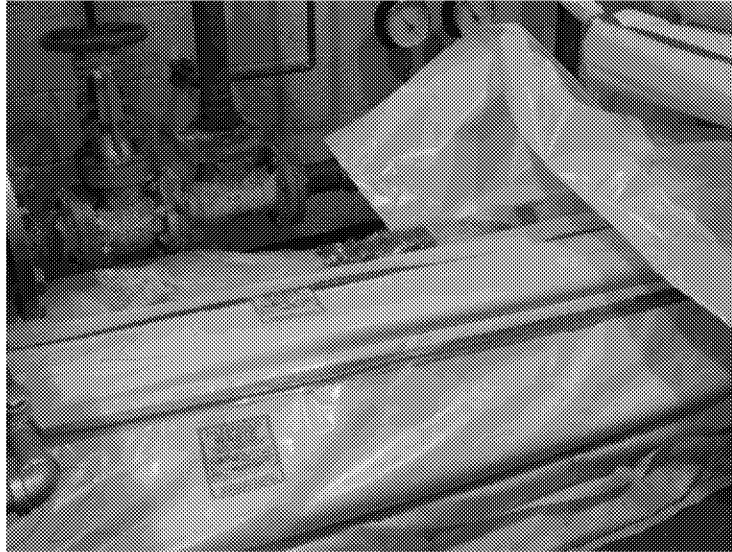
## Removed Fixtures not Labeled or Stored Properly

In this example, all of the removed fixtures are individually wrapped and stored in a locked area until they are picked up for proper disposal in a TSCA landfill. These light fixtures were wrapped correctly, but had the incorrect identification sticker and were left in the fire pump room. They should be stored in a secure room with a curb or other protection and not have floor drains.
